## MARYLAND HISTORICAL TRUST

## INVENTORY FORM FOR STATE HISTORIC SITES SURVEY

1 NA	ME				
HISTO	RIC				
		's Catholic Church	n	* **	
	R COMMON				
st.	Joseph	's Catholic Church	n		
2 LO	CATION	7			
	T& NUMBER	e, 1.5 miles sout	of P+ /10/1 (	ongt to ohumoh)	
CITY, T		e, 1.) miles soud	11 01 Rt. 404, (	CONGRESSIONAL DISTR	ICT
Cor	rdova	VICINITY OF Fi		First	
STATE				COUNTY	
	yland			Talbot	· · · · · · · · · · · · · · · · · · ·
3 CLA	ASSIFIC	ATION			
C	ATEGORY	OWNERSHIP	STATUS	PRES	ENTUSE
راه	STRICT	PUBLIC	OCCUPIED	AGRICULTURE	MUSEUM
<u> </u>	ILDING(S)	PRIVATE	_UNOCCUPIED	COMMERCIAL	PARK
ST	RUCTURE	вотн	WORK IN PROGRESS	EDUCATIONAL	_PRIVATE RESIDENCE
SIT		PUBLIC ACQUISITION	ACCESSIBLE	ENTERTAINMENT	RELIGIOUS
_08	JECT	IN PROCESS	¥YES: RESTRICTED	GOVERNMENT	SCIENTIFIC
		BEING CONSIDERED	YES: UNRESTRICTED	INDUSTRIAL MILITARY	TRANSPORTATION
			NO	WILLIAM!	OTHER
4 OW	NER OF	PROPERTY			
NAME					
Dio	cese of	Wilmington		Telephone #:	
STREE	T & NUMBER				
CITY, T	OWN			STATE . Z	ip code
	mington		VICINITY OF	Delaware

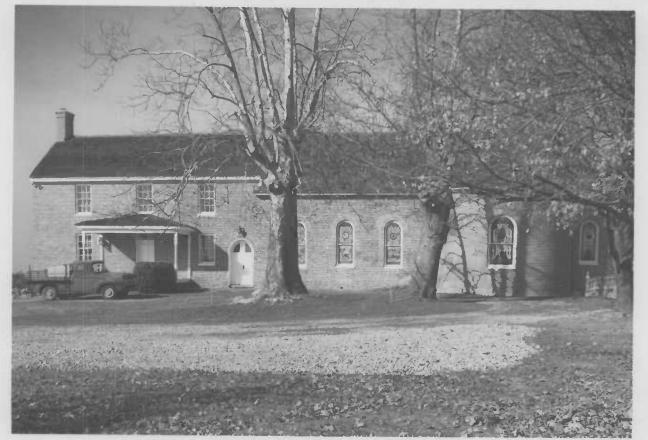
St. Joseph's R.C. Church T- 73 de 1.2 114% 12/20 M. Bourne S.E. elev.

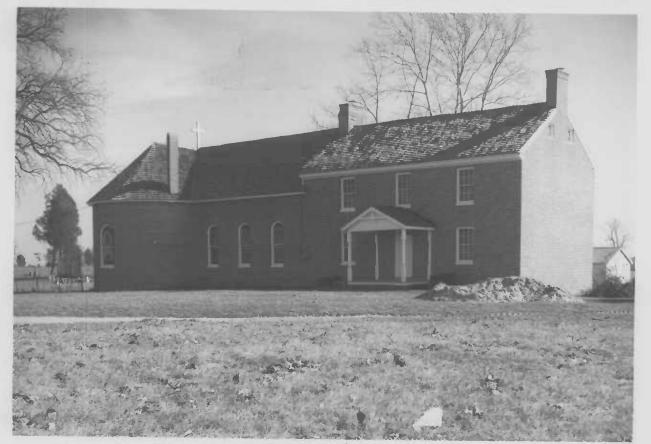
\$ N.W elev.

St. Joseph's R.C. Church

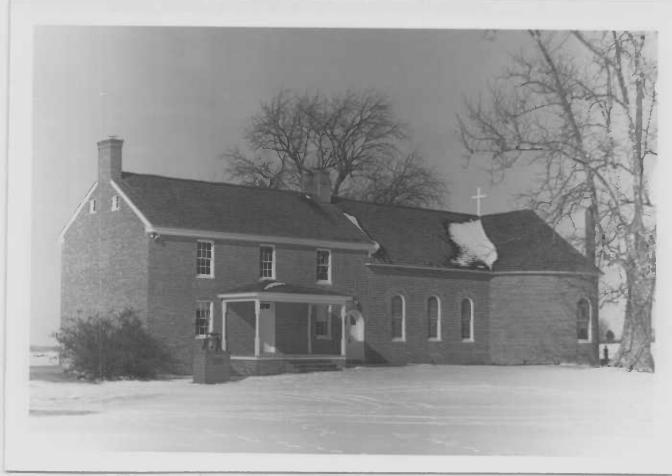
St. Joseph Church\*
Near Cordova, Md. 21625
Thomas Lee, Photographer
Photo taken January 25, 1985
Negative attached to Application
St. Joseph Church and House seen from a South Eastern side of the building. The Photographer was facing North West.
Photo # 1 of 2

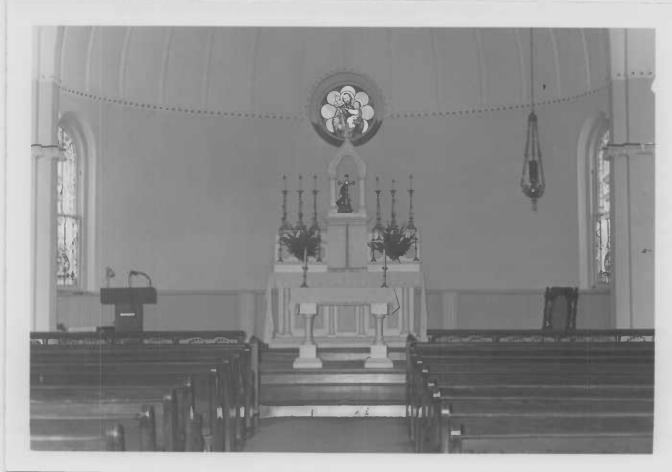
St. Joseph Church
Hear Cordova, Nd. 21625
Thomas Lee, Photographer
Photo taken January 25, 1935
Hegative attached to Application
St. Joseph Church interior showing the Altar Section in the
Cloverleaf section of the Church. The photographer was facing North
Photo 2 of 2
